A Novel Approach for Evaluating Protective Coatings Performance in Wastewater Environments

THE WASTEWATER MARKET PRODUCT INITIATIVE

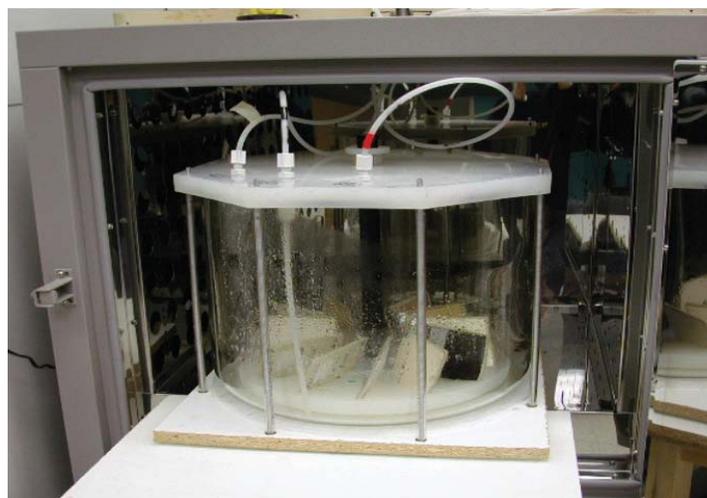
Figure 1

EIS readings were taken before the coating was exposed to the test; intermediate readings were also monitored at 10 and 20 days and at the completion of the test duration. The four readings were crucial to determine if the polymer was attacked or breached during the test. Any polymer degradation would be easily detected by a decrease in the measured impedance.

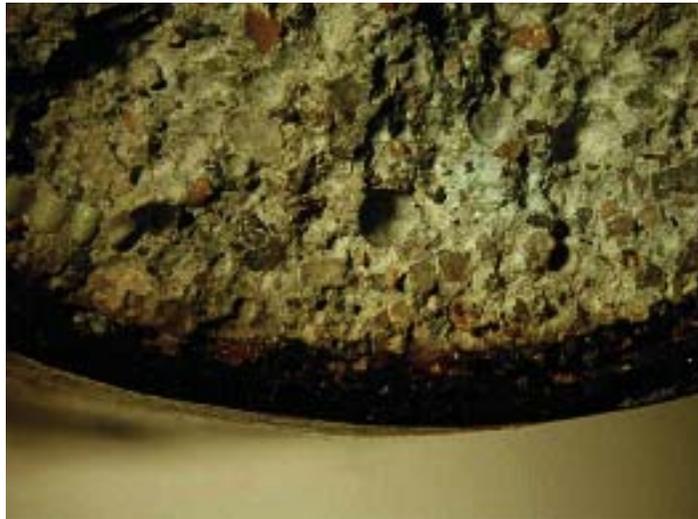
Figure #8
Series 46H

Figure #8 shows the concrete core coated with Series 46H that has been severely attacked after only 28 days of exposure in the chamber. This confirms the poor EIS number previously obtained for the Series 46H on the steel coupon and also duplicates the real life mode of failure of this coating.

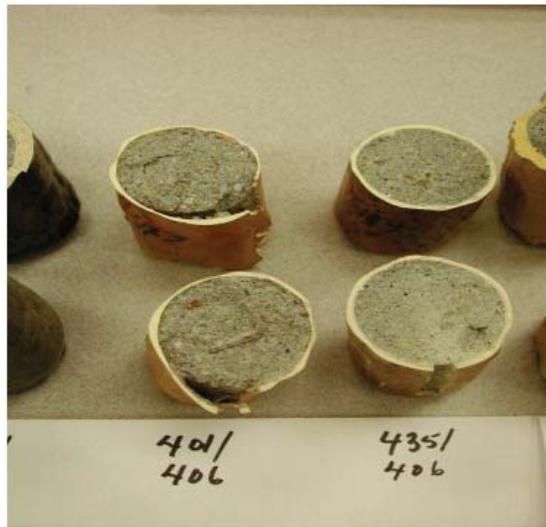
Figure #9
401/406 and 435/406

Series 401/406 and 435/406 did not blister, but showed the typical dark spots associated with sulfuric acid droplet exposure. The discoloration penetrated the 406 topcoats for both samples by approximately 1 to 3 mils. However, the 401/406 sample cracked, permitting acid to reach the concrete. The system using 435 as a primer kept its adhesion and film integrity.
