CASE HISTORIES

Lining Prevents Biogenic Sulfide Corrosion In Wastewater Systems

VAUGHN O'DEA—Tnemec Co., Inc., Kansas City, Missouri

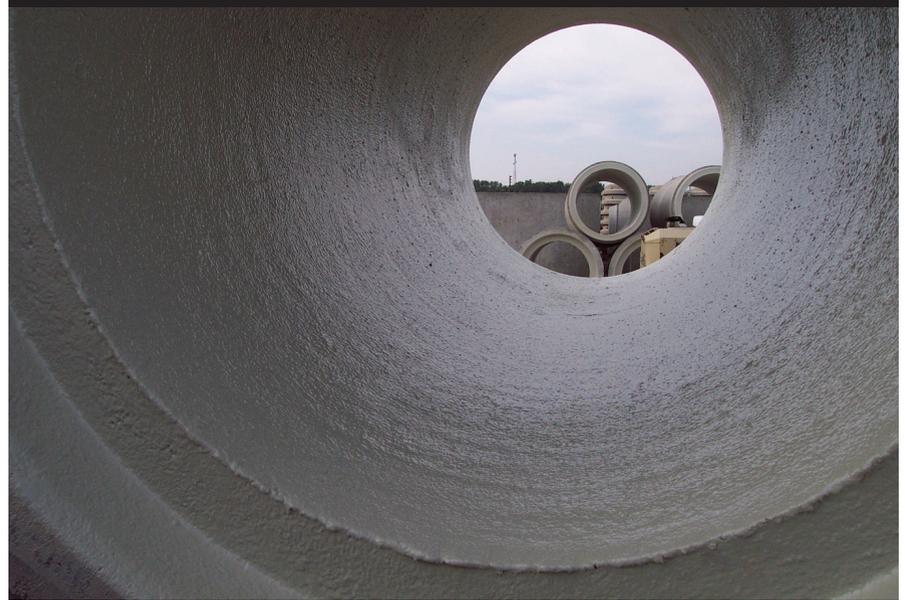
FIGURE 1

Typical 48-in. precast sewer interceptor lined with a 100% solids, fiber-reinforced polyamine epoxy for elevated H_2S resistance.

Federal and municipal authorities are in general agreement that the nation's wastewater collection system infrastructure, including sewer interceptors (Figure 1), manholes (Figure 2), and lift stations (Figure 3), is deteriorating at an alarming rate. The U.S. Environmental Protection Agency (Washington, DC) has estimated that in the next 10 years, the United States will have to invest more than \$11 billion to upgrade existing wastewater collection systems, more than \$24 billion for new sewer construction, and nearly \$50 billion to improve combined sewer overflow problems.¹

The 48-in. diameter concrete pipe was fabricated in 10-ft (3-m) sections. Each section was specified to be abrasive-blasted before spray application of the fiber-reinforced modified polyamine epoxy lining. The coating was applied with a high-pressure, airless spray pump at 80.0 to 125.0 mils DFT. The total project required more than 1,600 sections of pipe and an estimated 2,500 to 3,000 gal (9,463 to 11,355 L) of coating material.

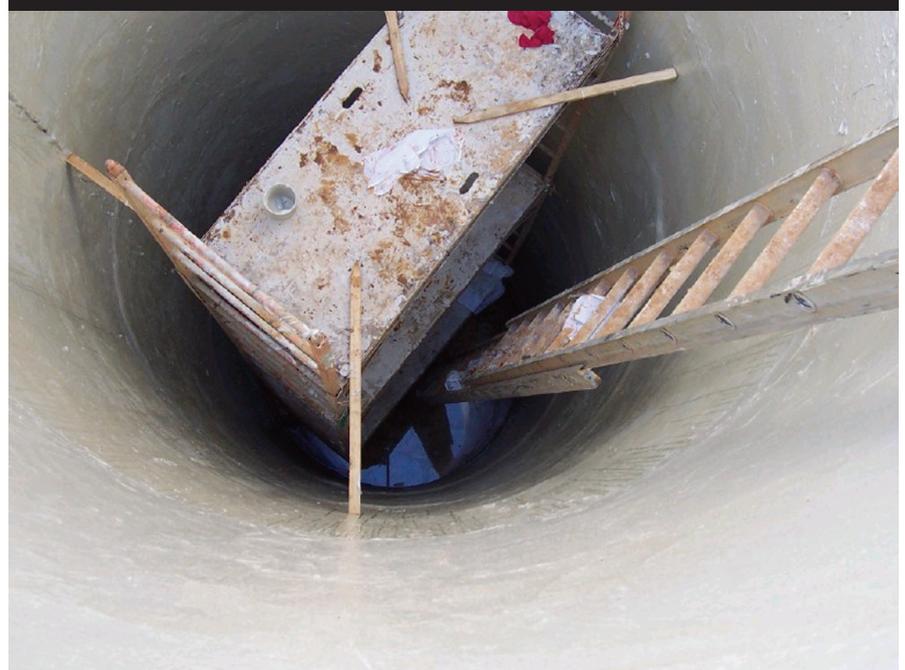
FIGURE 2

Precast manhole protected from biogenic sulfide corrosion using 100% solids, fiber-reinforced epoxy liner.

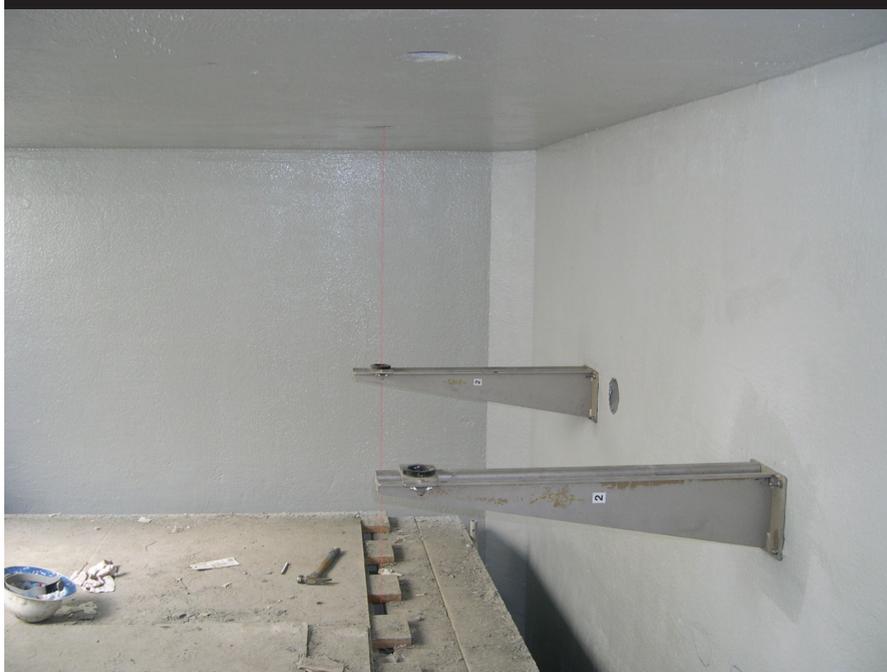
FIGURE 3

Finished appearance of a lift station restored with an epoxy coating thin overlay, then lined at 125 mils with a 100% solids epoxy mortar and 15 to 20 mils of a 100% solids epoxy glaze coat.

Trowel-applied epoxy mortars lend themselves to rehabilitative projects where the substrate is highly eroded and a thicker film build is required to create a contiguous surface. Such a coating system was used in the Village of Lyons, New York, where biogenic sulfide corrosion caused serious damage to the concrete substrate in a lift station wet well.

The highly eroded surface was pressure-washed and abrasive-blasted before an epoxy-modified cementitious resurfacer was trowel-applied to patch the deep holes and resurface the damaged concrete. After the substrate was resurfaced, a two-component, 100% solids polyamine epoxy mortar was trowel-applied at 1/8-in. (3.2-mm) thickness and backrolled using a 1/4-in. (6.4-mm) nap roller to smooth and tighten the system. A 100% solids polyamine epoxy glaze coat was then roller-applied as the top-coat at 15.0 to 20.0 mils dry film thickness (DFT) to provide added permeation protection.

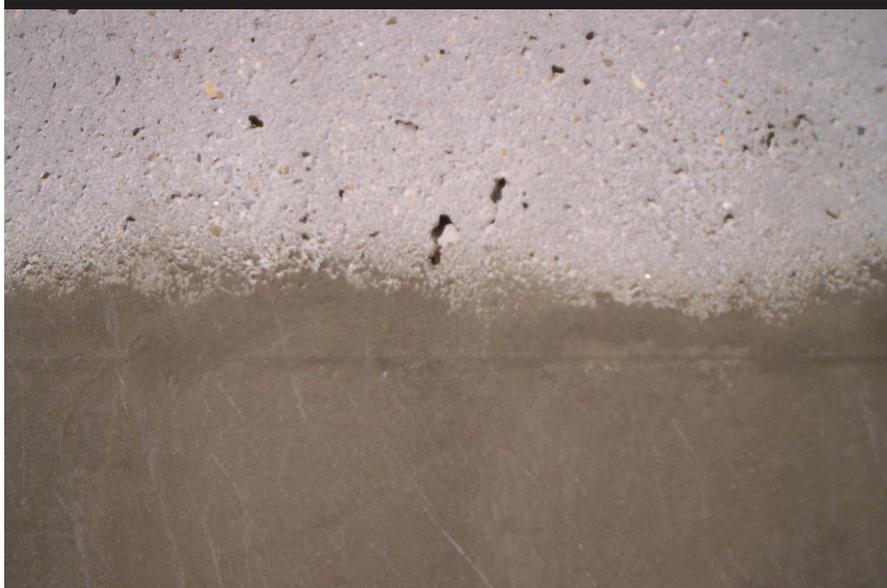
FIGURE 4

Typical cast-in-place concrete wall containing exposed voids and bugholes (upper half of photo) and application of a greenish-grey epoxy-modified cementitious thin overlay (lower half) to create a contiguous surface for coating.

A critical consideration for preventing permeation of these protective coatings is proper surface preparation of new and existing concrete following industry standards, such as NACE No. 6/SSPC-SP 13, "Surface Preparation of Concrete."⁴ This joint standard includes a requirement for filling voids, bugholes, and other cavities in the concrete before a coating is applied (Figure 4). Otherwise, air trapped in these cavities can be released into or through the protective coating, creating pinholes and holidays. The escaping air is described as bughole-induced outgassing.⁵

Among the materials available for filling bugholes are epoxy-modified cementitious resurfacers, also known as epoxy-modified cements. These materials are applied to the concrete as a thin overlay at an approximate thickness of 1/16th in. (1.6 mm). The epoxy-polymer modification allows the cementitious resurfacer to be applied as a thin patch material, while increasing its density to make the mortar less susceptible to outgassing when topcoated.

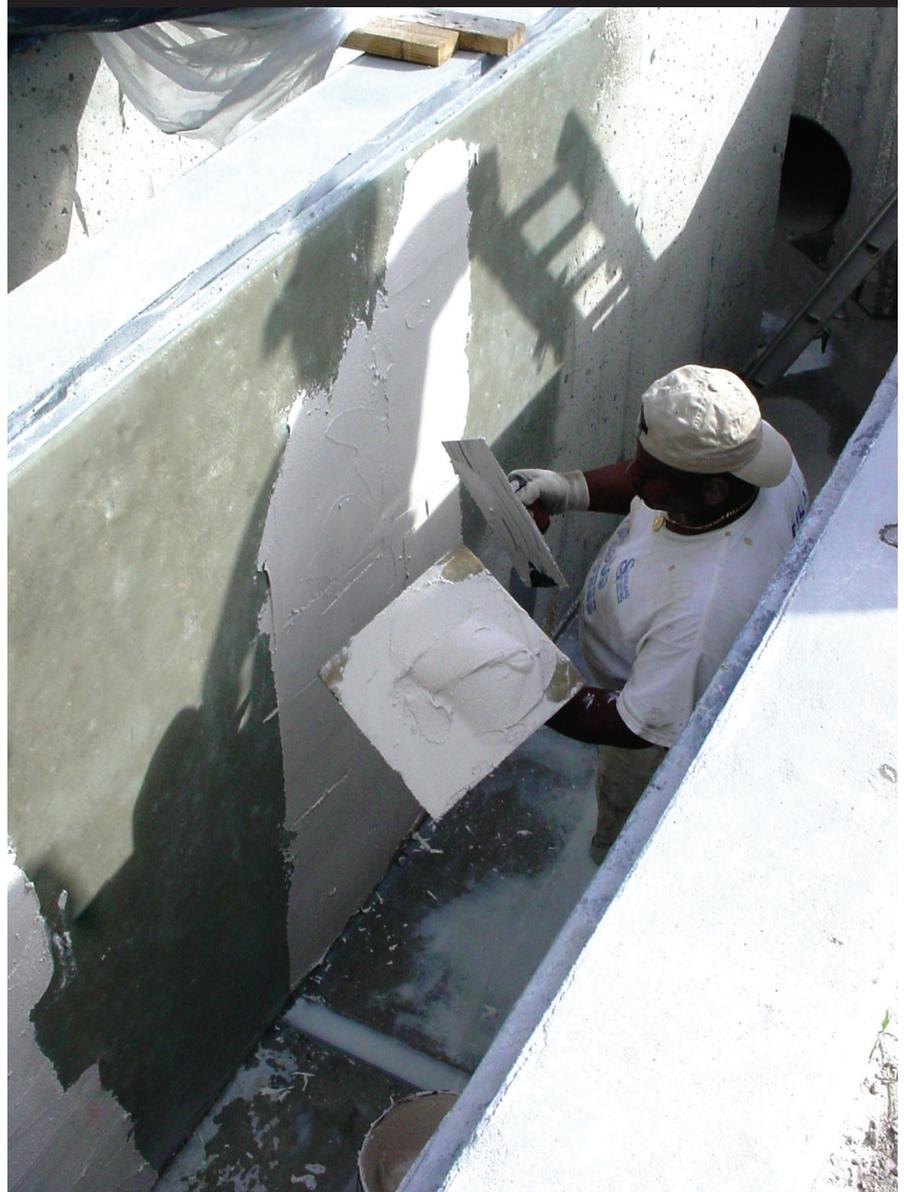
FIGURE 5

Trowel application at 125 mils of a 100% solids epoxy mortar system designed for elevated H₂S permeation resistance.

A 100% solids epoxy protective coating system designed with exceptionally low H_2S permeability and H_2SO_4 resistance is available for existing and new collection system substrates (Figure 5). Trowel-applied epoxy mortars feature aggregate reinforcement, which makes the film coef-
