CASE HISTORY

Restoring a Sludge Holding Tank at a Wastewater Treatment Plant Using High-Performance Coatings

VAUGHN O'DEA, *Tnemec Co., Inc.*

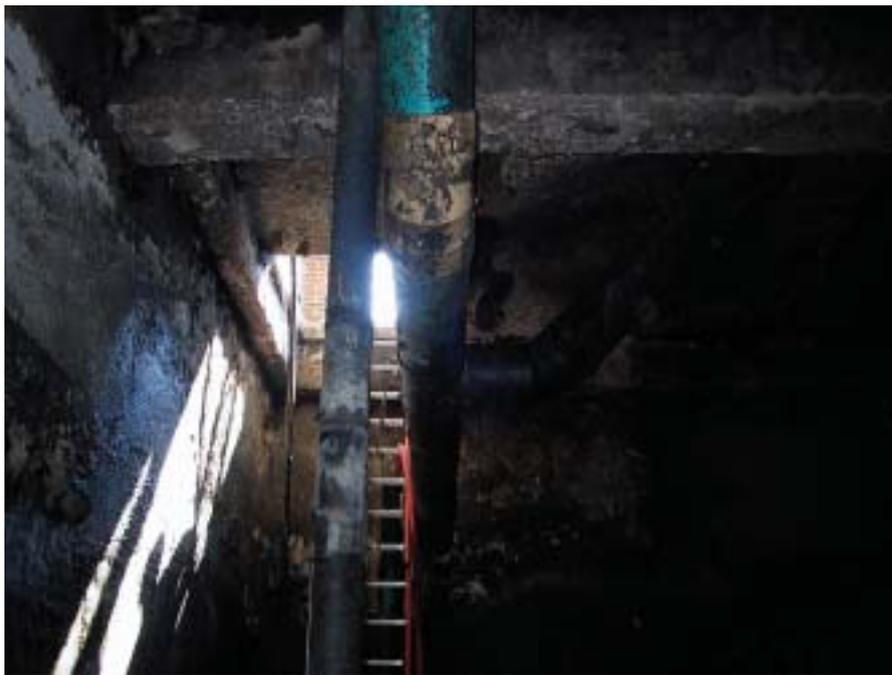
FIGURE 1

The plant experienced a serious hydrogen sulfide (H₂S) corrosion problem in 1993 that was repaired using a conventional, acrylic-modified cementitious resurfacer and coal tar epoxy (CTE) coating. Failure of the CTE coating occurred within 2 years, leading to coating delamination. Frustrated by the lack of protection by an otherwise traditional product for these severe applications, the city elected to forego repair. This restoration delay caused extensive chemical attack of the concrete substrate—upwards of 2 in. (50 mm) of concrete loss—exposing some rebar and thereby raising structural concerns for the two sludge tanks (Figure 1).

Deterioration of concrete sludge holding tank after 10 years of H₂S corrosion.

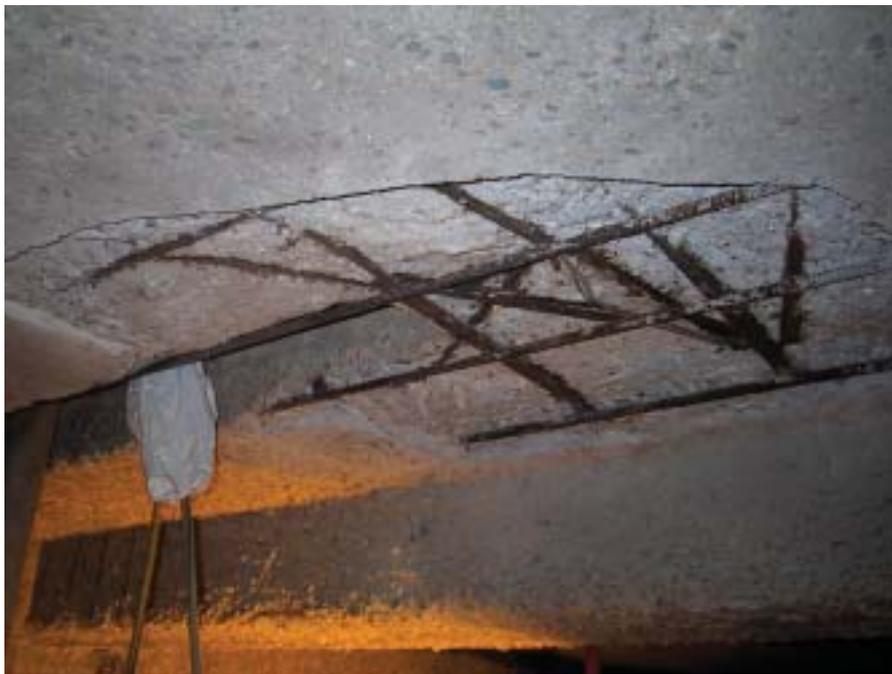
FIGURE 2

Concrete surfaces after water jetting and hand chipping.

plished with high-pressure water cleaning of 5,000 psi (35 MPa), and by chipping away damaged concrete by hand. Twenty percent of the tank's substrate had been

damaged so severely that large areas of 1/2 to 3 in. (13 to 76 mm) of concrete had to be restored with shotcrete to provide the necessary rebar cover and to bring the

surface back to the original plane. After curing for 7 days according to American Concrete Institute (ACI) Standards, the shotcrete was abrasive-blasted to remove the membrane curing compound and any laitance formed during troweling and curing according to NACE No. 6/SSPC-SP 13¹ (Figure 2). At this stage, the coating inspector evaluated the progress for quality control.

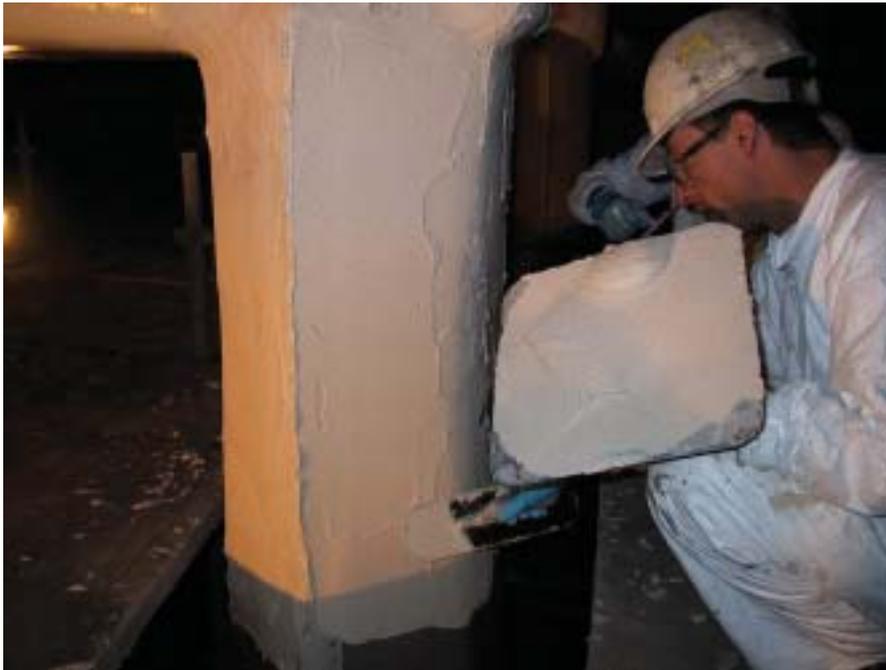
FIGURE 3

Trowel application at 125 mils of 100% solids epoxy mortar system designed for elevated H₂S permeation.

When this substrate restoration was complete, the applicator trowel-applied at 125 mils (3 mm) of 100% solids epoxy mortar, especially designed for permeation resistance of elevated H₂S gas and reaction products (Figure 3). This coating was then backrolled to close the film and to make the lining pinhole free.

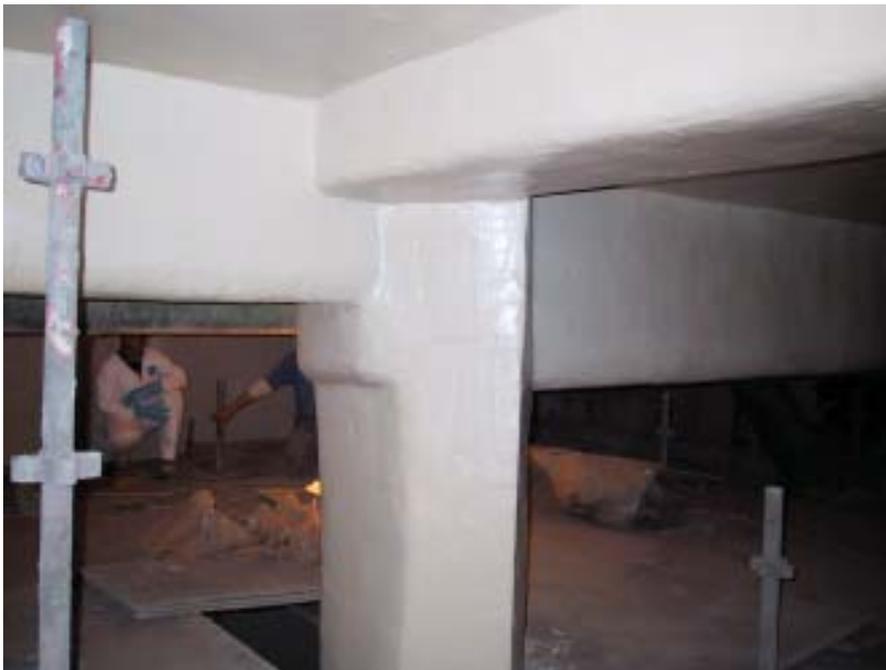
FIGURE 4

Appearance of the finished coating.

Following holiday testing, the applicator completed the job with a final roll coat of a modified polyamine epoxy lining at 15 to 20 mils (0.4 to 0.5 mm) to seal the few holiday pinholes detected by the high voltage spark test (Figure 4).
