# HydroFlon

FOR A LASTING IMPRESSION, COAT WITH BRILLIANCE.

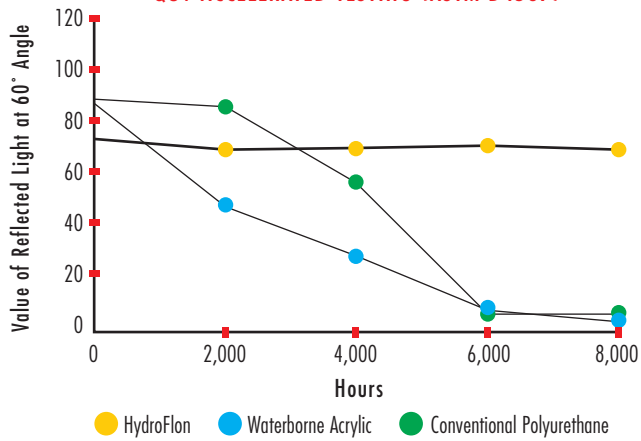
**GLOSS RETENTION**  
QUV ACCELERATED TESTING (ASTM D4587)

As illustrated on the graphs above, HydroFlon showed almost no color or gloss change after 8,000 hours of accelerated UV exposure, proving its outstanding aesthetic stability. In comparison, conventional polyurethane held color relatively well but lost gloss less than halfway through the test. Traditional acrylic showed significant color shift around 4,000 hours and began losing gloss almost immediately.
